ROSTOCK (GERMANY)

1. GENERAL DESCRIPTION OF THE AREA

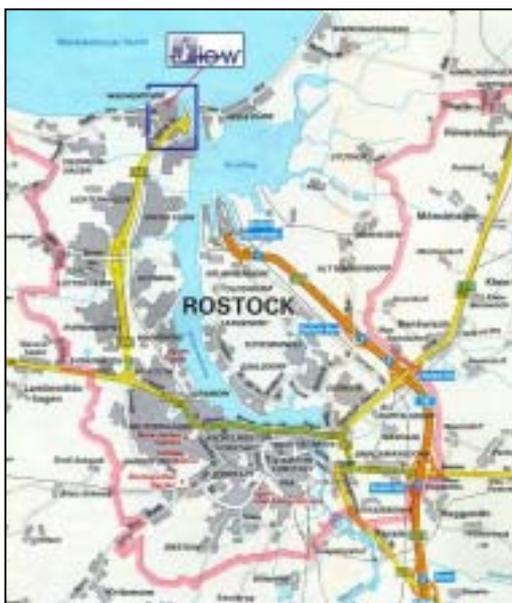
Fig. 2: Map of the case area.

The case area is shown in Figure 2, and is split in six different areas:

1. Warnemunde west	F144,550-F145,650
2. Warnemunde mitte	F145,650-F147,080
3. Warnemunde hohe dune	F148,730-F151,800
4. Markgrafenheide	F151,800-F153,250
5. Moorwiesen	F153,250-F156,390
6. Rostocker Heide	F156,390-F160,600

West of Warnemunde, the Stoltera cliffs are found (moraine cliffs). From Warnemunde west to Moorwiesen, the coast exists of coastal plains. Further east at Rostocker Heide, there are cliffs present again (sandy cliffs). Most of the locations are named in the map, only Moorwiesen and Rostocker Heide are not on the map.

In between Warnemunde mitte and Warnemunde hohe dune, the harbour entrance of Rostock is located. A breakwater has been built at the western site of the harbour entrance.

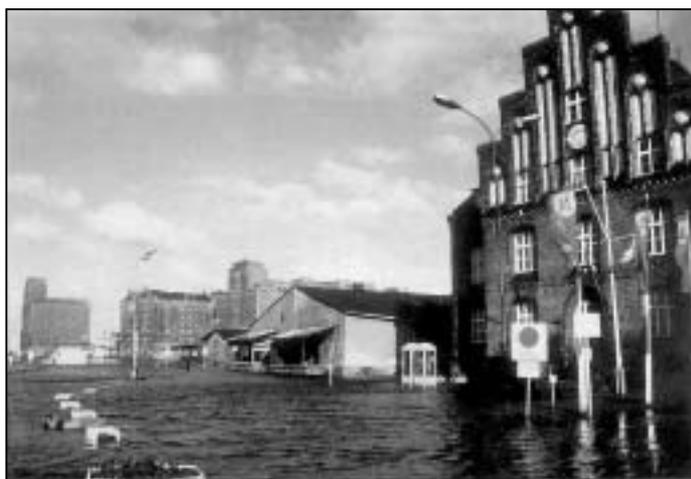
Fig. 3: Result of the collapsing of a dike due to storm surge.

Acute erosion due to storm surges (waves and water levels at extreme hydraulic conditions) causes extreme changes of the coast in a very short time. These storm surges are normative for the design of the coastal protection works. In Warnemunde, the dikes have collapsed 8 times in the last hundred years due to heavy storm surges. In the picture one example is shown of a dike collapsing due to a heavy storm surge.

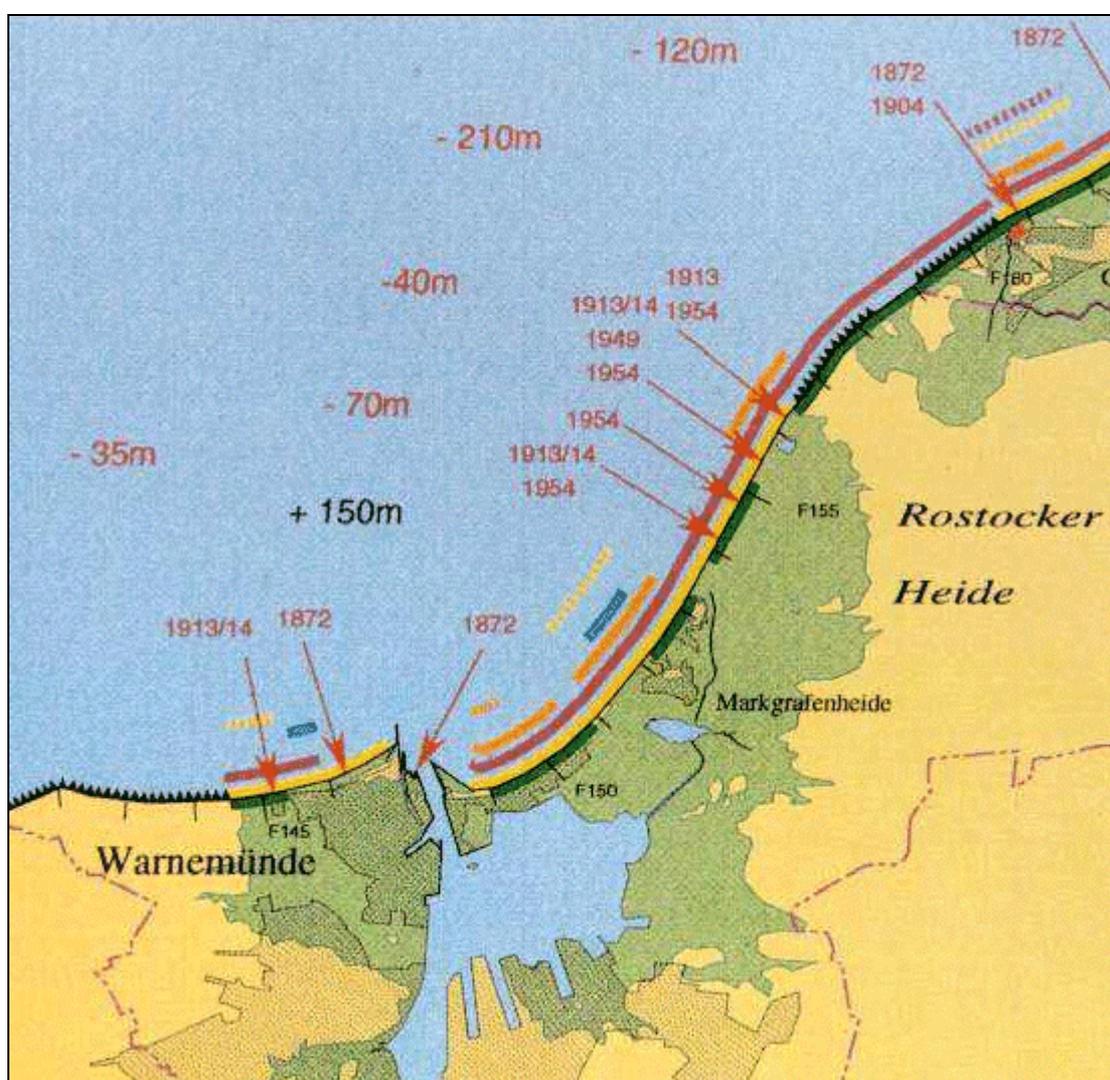
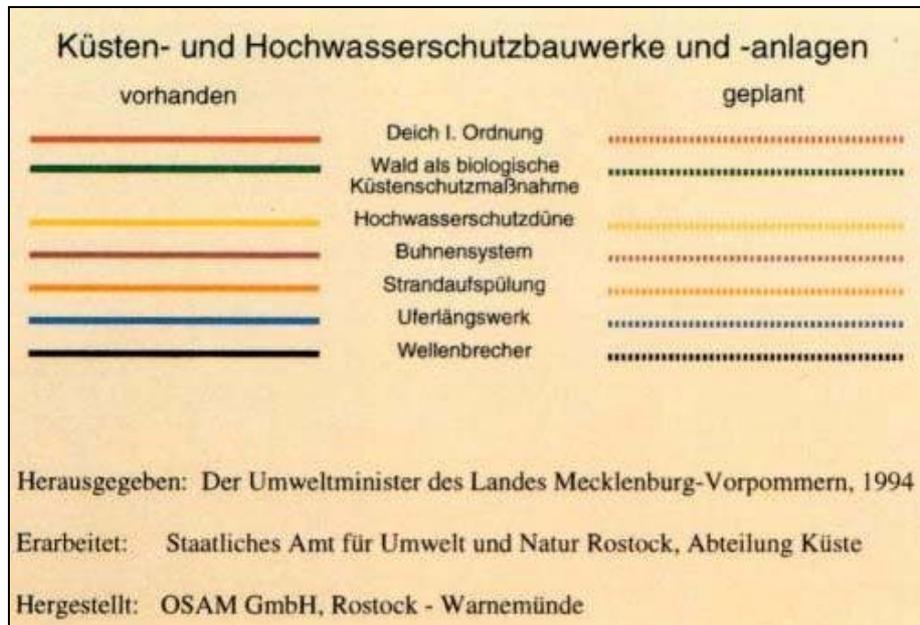
Fig. 6: Erosion at case area and taken measures against the erosion.

In Figure 3, the case area is shown in more detail. In the figure, the erosion and sedimentation in the last 100 years is shown. The red letters imply an erosion rate, while the black letters imply a sedimentation rate. Also, the years that a flooding took place due to a heavy storm surge are indicated at different locations.

The average erosion in the entire province of Mecklenburg-Pommern is 34m/ 100 years. West of the harbour entrance the erosion is about average, 35m/ 100 years. A flooding took place at the coastal plains of this area in two occasions. Because of the easterly directed net long shore transport, west of the break water accumulation of sand occurs; 150m/ 100 years.

East of the harbour entrance, the erosion increases. At the coastal plains, the coast has receded 70 to 40m in a 100 years. At the cliffs of the Rostocker Heide, the erosion rate increases dramatically; 210-120 m/ 100 years. On the coastal stretch of Kkm F154,000 to F156,500 (plains Rostocker Heide) severe flooding occurred ten times in the last 100 years. The last severe flooding at the case area took place in 1954.

For Mecklenburg-Vorpommern the average population rate of possible flooding areas is 88 persons/km². This indeed implies a moderate risk. However, this is an average population. In Figure 3, the green area implies the possible flooding area at Warnemunde. This area is not so densely populated, however it does represent great economic values because of the presence of the harbours. The case area can be considered as being at moderate risk.

The erosion threatens the beaches, and thereby the function recreation and tourism. Furthermore, the safety of the hinterland is threatened. This includes the people living in the threatened area (see green area in Figure 6), though the population is not so dense in this area, and the economic values in the form of the industry of the harbour. Nature conservation is not threatened by erosion; it can be stimulated by dynamic maintenance of the dune coasts.

In Figure 3 and Table 1 all the taken measures in the case area are shown. Different colours stand for different types of coastal protection. The dashed lines imply the planned measures.

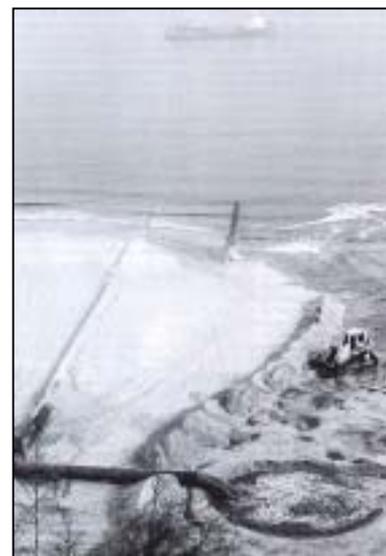
Fig. 7: Nourishment at the beach.

Warnemunde Hohe dune: nourishment of 60.000 m^3 sand over 500 m of coast, reason is the deficiency of sand at the coast that causes the need for repeated nourishments every 2-3 years. Estimated costs: €0.2 Million.

The nourishments take place downstream of the harbour entrance, at Warnemunde Hohe dune and Markgrafenheide. The technical details for the nourishments at Hohe dune are shown in Table 3. Repetition of the nourishments is needed every 2-3 years to prevent the coastline from receding. From the table it can be seen that the first nourishment was placed over a long stretch of 2,2 km, the following nourishments from 1976 were all placed as far upstream as possible (thus directly downstream of the harbour entrance) over a stretch of 100-400 meters. The average amount of sand varies from 100-400 m³/m¹.
