## HYLLINGEBJERG – LI SELEJE (DENMARK)

## 1. GENERAL DESCRIPTION OF THE AREA

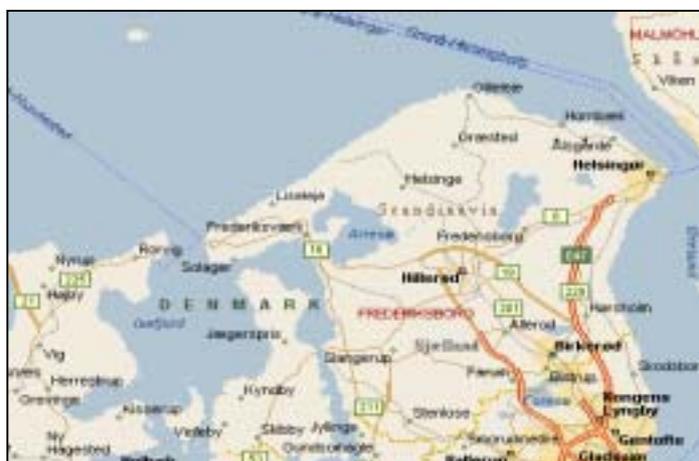
Fig. 2: Coastal protection area Liseleje-Hyllingebjerg.

The coast of Zealand is indented by numerous deep bays and fjords; the Ise Fjord in the north, with its branches the Roskilde Fjord on the east and the Lame Fjord on the west. At the Liseleje-Hyllingebjerg case area, in the west cliffs with a height of about 25 m are present. In front of the high cliffs, consisting of fine sediment, narrow beaches are present. Towards the east, the cliffs become lower and the beaches become wider.

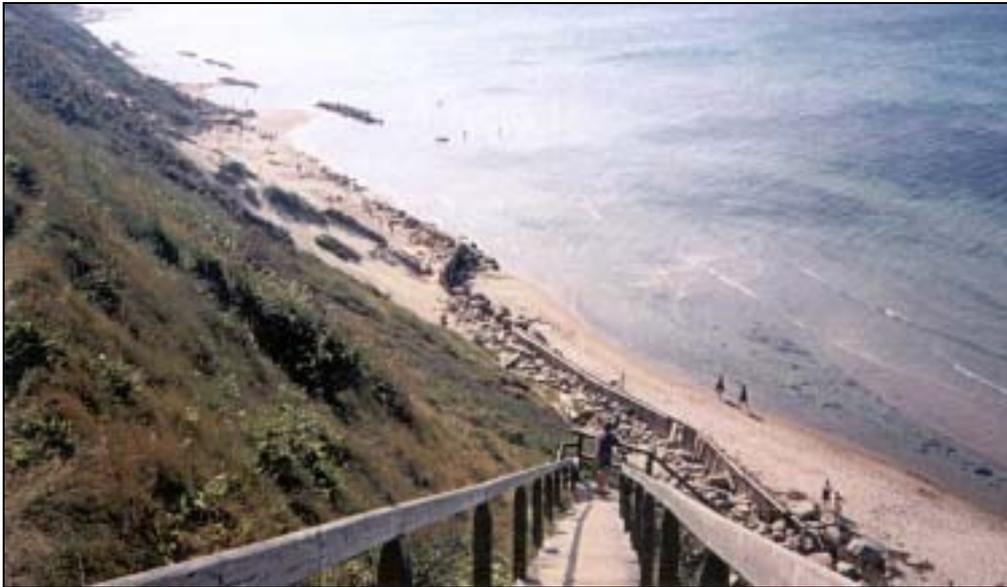
*Fig. 3: Situation before coastal protection; old measures and narrow beaches are clearly seen.*

Before the project started, several local coastal protection measures disturbed the sediment balance along the coastline. Hence, certain parts of the cliff remained without protection and were thus being more eroded than others. This situation should be overcome by creating a common project.

The erosion is structural; it is caused by a net sediment transport gradient in combination with human interference. Due to human interference, namely removing the large stones and local coastal protection measures, the sediment balance has been disturbed and the coast is no longer stable and structural erosion of the coast has started. The estimated average net sediment transport is 10,000 to 30,000 m<sup>3</sup>/year eastwards. The transport was estimated with the help of a coastline analysis. Acute erosion due to heavy storm events also occurs.

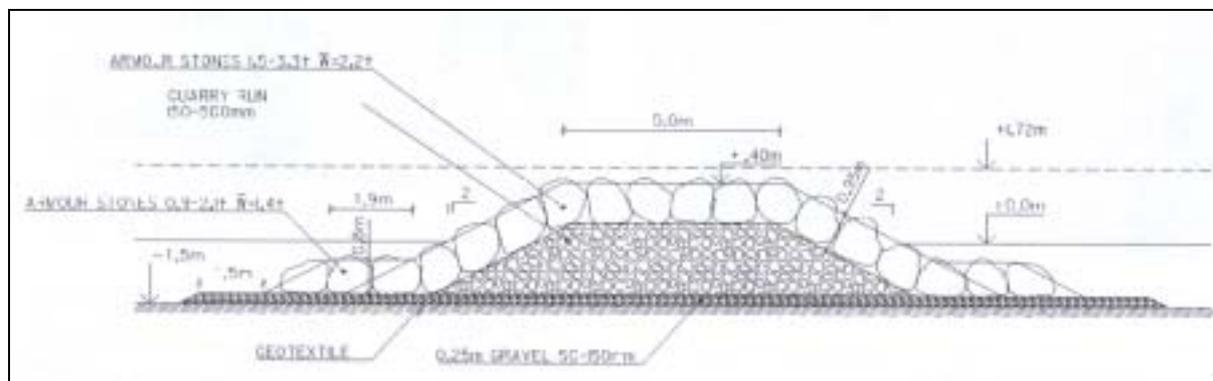
Fig. 5: Typical cross section of a breakwater.

In the eastern end the protection consists of a segmented breakwater consisting of long coastal breakwaters whereas in the western end the distance between the breakwaters are increased and they become singular long coastal breakwaters. The detached breakwaters are located in water depths ranging from 0.5 to 2.0 m and are designed with low crest elevations (+0.5 to +1.4m above mean sea level) to minimise the visual impact. A typical cross section of the detached breakwaters, having a wide crest to be stable against heavy overtopping, is shown in Figure 5.

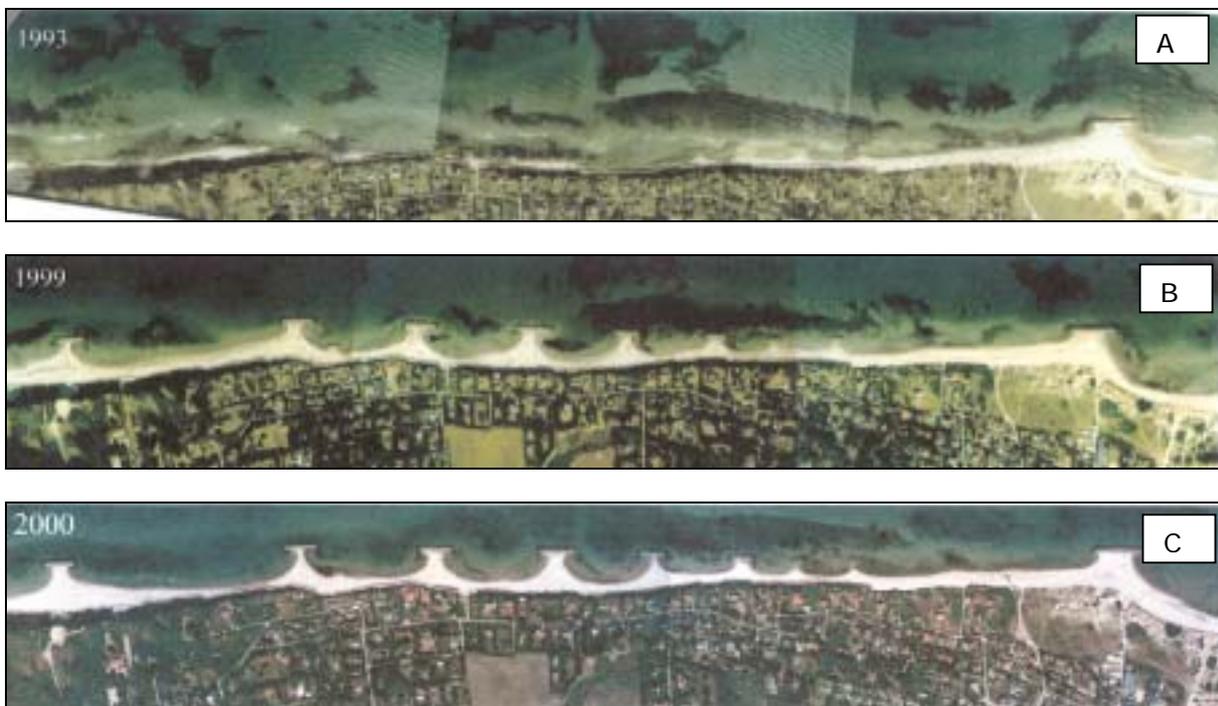
*Fig. 10: Aerial photos of the case area in 1993 (A), 1999 (B) and 2000 (C).*

An aerial photo of the coast in 1993 in Figure 10 (Chapter 4) shows that the beach is narrow or non-existing except just to the west of "Liselejemolen".

The coast protection has now been in function for a few years and is working well even though that it has been exposed to two severe storms where one was the worst in the 20<sup>th</sup> century. A monitoring programme has not been implemented and instead visual observations and aerial photos are used to assess the performance of the coastal protection work. Figure 10 shows aerial photos of the condition in 1993 before the project was started, in 1999 directly after completion of the project and in 2000, after some severe storms.

In June 2001, large amounts of sand have accumulated behind the new detached breakwaters and are forming large tombolo's, which increase the recreational value of the beach considerably. The large tombolo's result in limited sand in a few of the bays between the detached breakwaters and a few landowners are critical now that they have not got an improvement locally. However, overall the system of breakwaters, nourishment and slope protection works well and is considered to be a success.

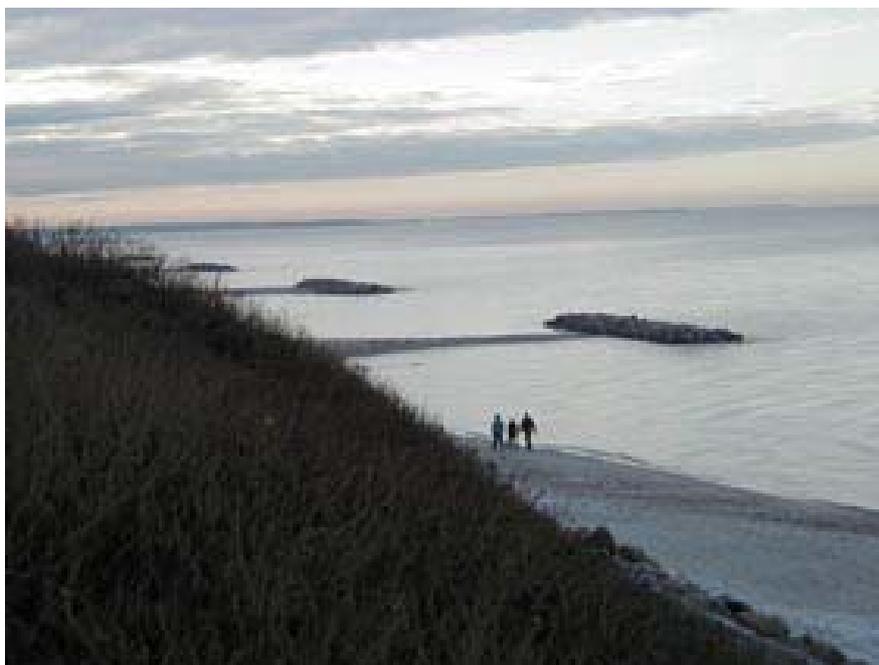
*Fig. 11: New breakwaters with the formation of tombolos behind it.*

The formation of tombolos has locally caused a shortage of sand in between the breakwaters. This causes a retreat of the coastline locally.
